# Drinking Water Audit Report

County:	Cork	Date of Audit:	25/03/2019
Plant(s) visited:	Glashaboy (Scheme Code 0500PUB3303)	Date of issue of Audit Report:	07/05/19
		File Reference:	DW2019/55
		Auditors:	Ms. Criona Doyle
			Ms. Regina Campbell
Audit Criteria:	• The European Union (Drinking Water) Regulations 2014 (S.I. 122 of 2014) as amended.		
	• The EPA Handbook on the Implementation of the Regulations for Water Services Authorities for Public Water Supplies (ISBN: 978-1-84095-349-7)		
	The recommendations specified in the EPA <i>Drinking Water Report</i> .		
	EPA Drinking Water Advice Notes No.s 1 to 15.		
	The recommendations in any previous audit reports.

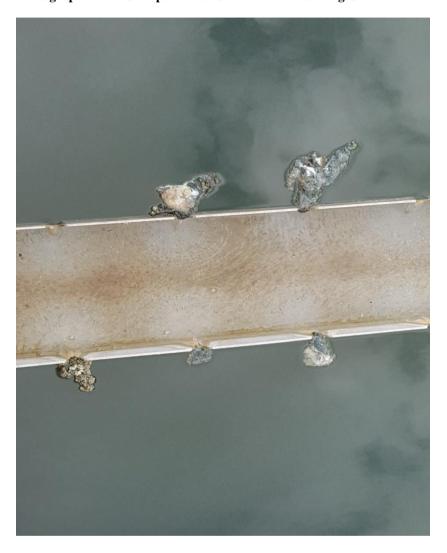
- k. On the day of the audit pin floc was visible quite high in the clarifiers and clumps of floc were collecting on the notches of the decanting channels (Photograph No. 1) which may indicate issues with the coagulation process.

Photograph No. 1: Clumps of Floc On Weirs of Decanting Channels

- 3. Irish Water should investigate the cause of the clumps of floc observed collecting on the notches of the weirs on the decanting channels. Irish Water should ensure that visual observations of the clarifiers (floc and sludge blanket) are recorded on a daily basis on the plant day sheet.

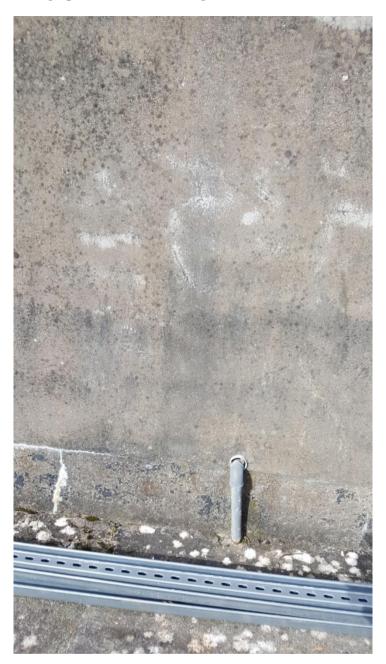
Photograph No. 2: Gas Oil Storage Bund

a. At the previous EPA audit in 2009 a recommendation was made in relation to the bund of the gas oil tank and the location of a pipe closed to the bund floor. No improvements appear to have been made (Photograph No. 2).

12. Irish Water should confirm if the integrity test of the marked gas oil tank storage bund, as recommended in the previous EPA audit, was carried out and measures enacted to ensure its integrity.
