Drinking Water Audit Report

County:	Kildare	Date of Audit:	8 th January 2015
Plant(s) visited:	Srowland Water Treatment Plant	Date of issue of Audit Report:	14 th January 2015
		File Reference:	DW2014/389
		Auditors:	Mr Darragh Page Ms Aoife Loughnane
Audit Criteria:	<ul style="list-style-type: none"> • The <i>European Union (Drinking Water) Regulations 2014 (S.I. 122 of 2014)</i>. • The <i>EPA Handbook on the Implementation of the Regulations for Water Services Authorities for Public Water Supplies (ISBN: 978-1-84095-349-7)</i> • The recommendations specified in the EPA Report on <i>The Provision and Quality of Drinking Water in Ireland</i>. • The recommendations in any previous audit reports.

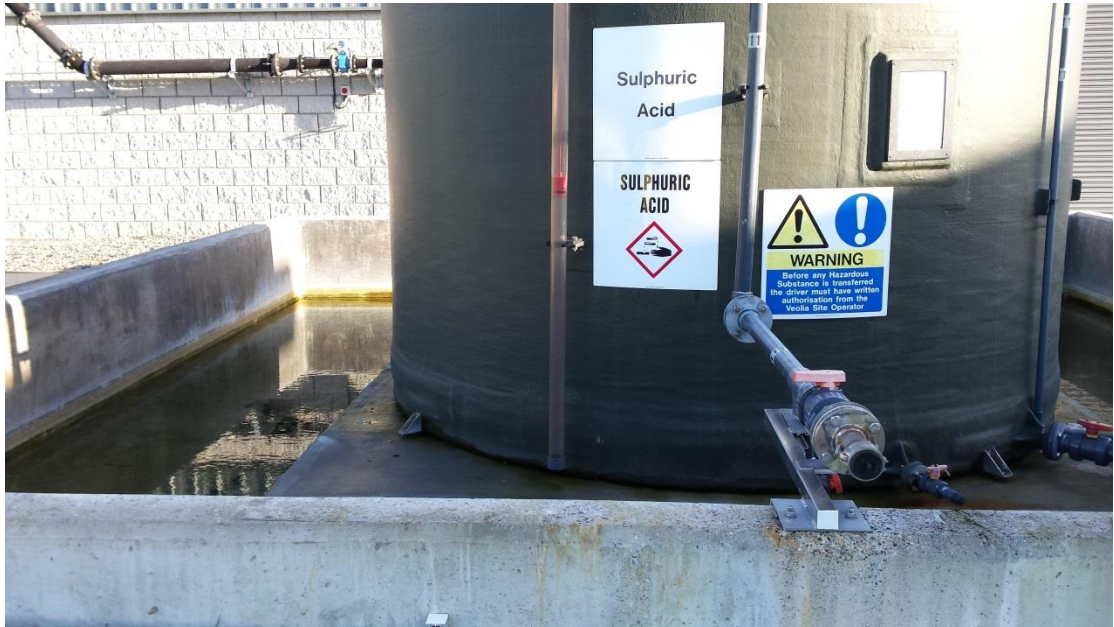
9.	<p>Chemical storage and bunds</p> <ul style="list-style-type: none"> a. All chemicals were stored within adequately bunded areas. b. The fill point for the sulphuric acid bulk storage tank was located on the wall of the bund (Photo 1).

Photo 1. Sulphuric Acid Fill Point.

7. Irish Water should ensure that fill points for storage tanks inside the bunds should be within the bunded area. Refer to EPA guidance document –“*IPC Guidance Note on Storage and Transfer of Materials for Scheduled Activities*”.

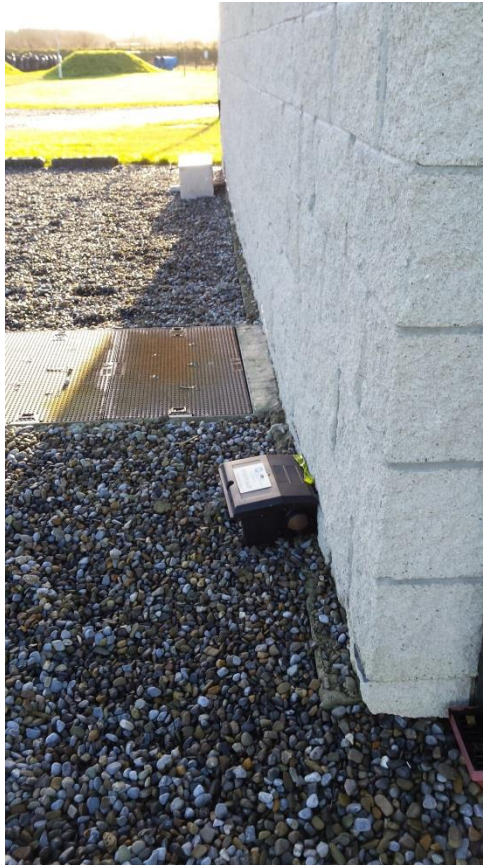
11.	<p>Management and Control</p> <ul style="list-style-type: none"> a. Rat bait points were located at numerous locations around the site (Photo 2). Veolia stated that these are used on an ongoing basis. The auditors pointed out that this is in contravention of EPA Advice Note No.13 – Pesticides in Drinking Water which states that the use of rodenticides should be avoided unless absolutely necessary and where they are used, it should be for a limited duration until the problem is brought under adequate control. b. Alarms at the plant were not being responded to in an appropriate manner at the time of the incident.

Photo 2. Rat bait point at Srowland Water Treatment Plant.

8. Irish Water should review the usage of rat bait at the Srowland WTP. The use of rodenticides should be avoided unless absolutely necessary and where they are used, it should be for a limited duration until the problem is brought under adequate control. Irish Water should have regard to EPA Advice Note No.13 – Pesticides in Drinking Water.
