Drinking Water Audit Report

County:	Kilkenny	Date of Audit:	15/11/2018
Plant(s) visited:	Bennettsbridge Regional PWS (Scheme Code1500PUB1002)	Date of issue of Audit Report:	29/11/2018
		File Reference:	DW2017/13
		Auditors:	Ms. Regina Campbell
Audit Criteria:	<ul style="list-style-type: none"> • The <i>European Union (Drinking Water) Regulations 2014 (S.I. 122 of 2014), as amended.</i> • <i>The EPA Handbook on the Implementation of the Regulations for Water Services Authorities for Public Water Supplies (ISBN: 978-1-84095-349-7).</i> • The recommendations specified in the <i>EPA Drinking Water Report.</i> • EPA Drinking Water Advice Notes No.s 1 to 15. • The recommendations in any previous audit reports.

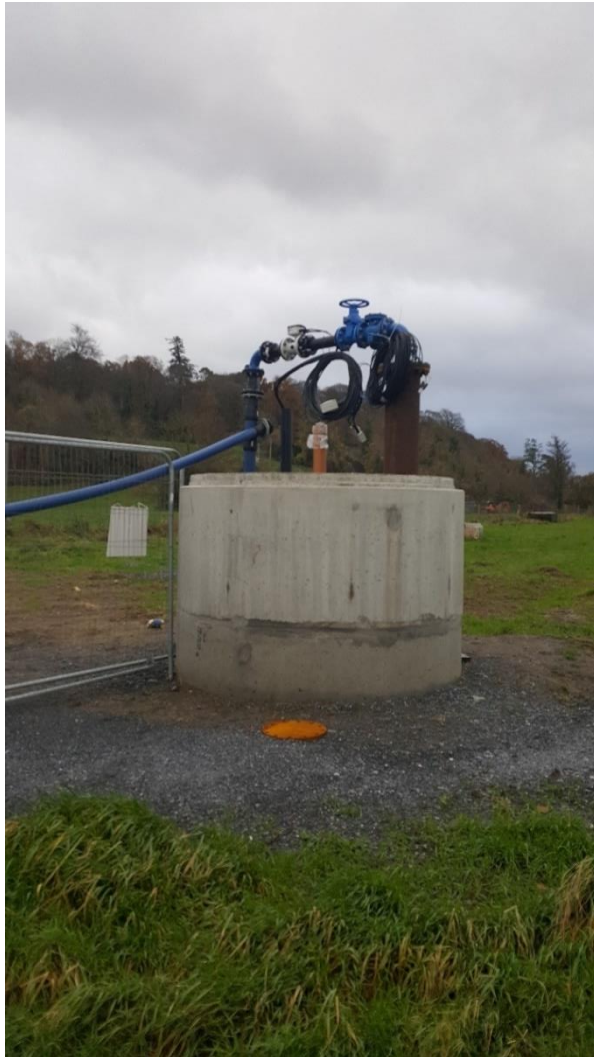
<p>Irish Water drilled a new trial borehole (referred to in this report as Borehole No. 4) during the summer 2018. The borehole underwent testing prior to going into production on 12/10/18. It is producing 30m³/hr at the moment. Irish Water said that Borehole No. 4 was being modified in its existing location to become a permanent borehole (see Photos 1 and 2). Irish Water advised in correspondence to the EPA (dated 09/11/18) that the geology at the site will only facilitate construction of a borehole to G2 or G3 standard. Irish Water advised that manganese levels in the new borehole are high but mixing with water from the other sources ensures that concentration in the final water is below the manganese parametric value.</p> <p>Raw water from the boreholes and infiltration gallery are mixed together in a sump prior to chlorination.</p> <p>I was advised by the caretaker that there are turbidity monitors on Boreholes 1, 2 and 3, on the infiltration gallery and on the final water. The turbidity monitors are not alarmed. There is no turbidity monitor currently on new Borehole No. 4. The caretaker also takes regular turbidity readings of the combined sources at the plant. The caretaker advised that the combined water turbidity readings are generally < 0.4 NTU. On the day of the audit, the HMI display showed a final water turbidity reading of 0.115 NTU.</p> <p>It was observed that cattle had been recently grazing on the field running parallel to the infiltration gallery and well-field. The field was fenced off to prevent animal access to the area where the boreholes and infiltration gallery are located. Irish Water were not able to verify when landowners were last written to in relation to the requirements of the <i>European Union (Good Agricultural Practice for the Protection of Waters) Regulations 2014 (SI No.31 of 2014)</i>.</p>

Photo 1 New Borehole No. 4

2. Irish Water should undertake the necessary works to ensure that Borehole No. 4 is constructed, sealed and protected in accordance with EPA Drinking Water Advice Note No. 14: Borehole Construction and Wellhead Protection.
3. Irish Water should confirm the Irish Water classification of Borehole No. 4.
4. Irish Water should liaise with Kilkenny County Council and confirm that landowners have been written to in relation to the requirements of the *European Union (Good Agricultural Practice for the Protection of Waters) Regulations 2014 (SI No.31 of 2014)*.
5. Irish Water should ensure that there is a continuous turbidity monitor on each of the raw water sources for this supply. These monitors should be linked to a recording device and generate an alarm in the event of a deviation from the acceptable turbidity levels.

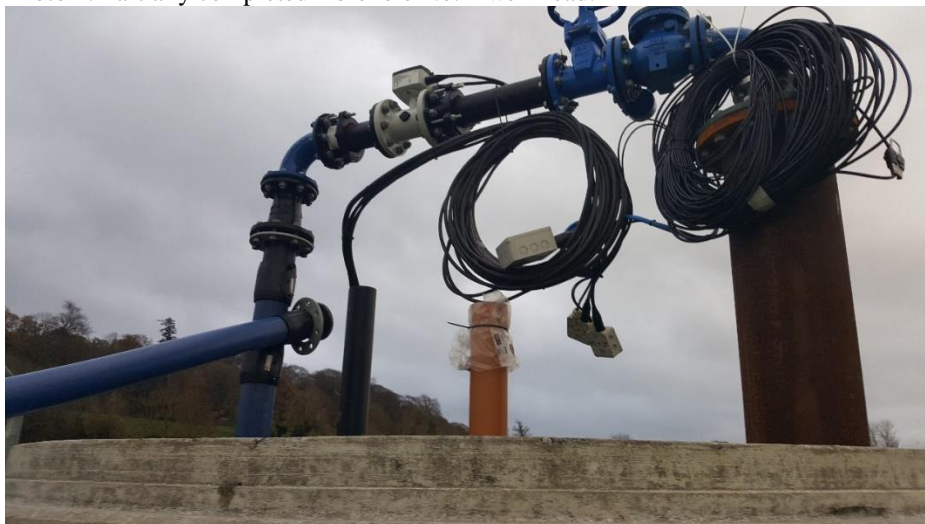
The audit also provided an opportunity to inspect the new Borehole No. 4 drilled during summer 2018. Irish Water should undertake the necessary works to ensure that the final borehole is constructed, sealed and protected in accordance with EPA Drinking Water Advice Note No. 14: Borehole Construction and Wellhead Protection.

Photo 2: Partially completed Borehole No. 4 well head.

- ii. Irish Water should undertake the necessary works to ensure that new Borehole No. 4 is constructed, sealed and protected in accordance with EPA Drinking Water Advice Note No. 14: Borehole Construction and Wellhead Protection.

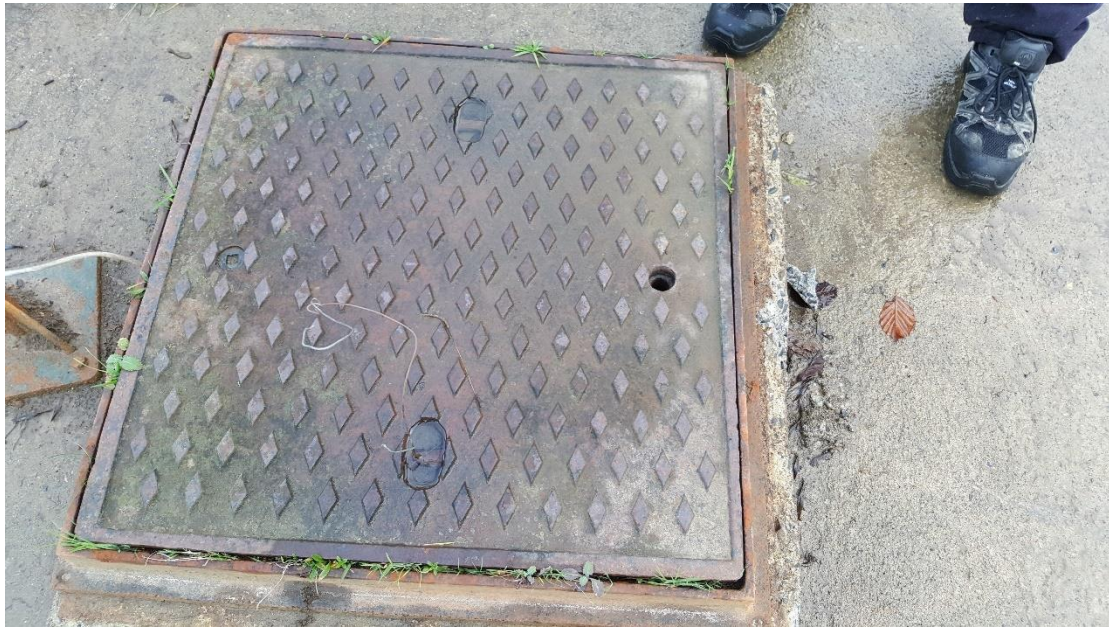
<p>3.</p>	<p>Treated Water Storage and Distribution Network</p> <ul style="list-style-type: none"> a. There are two reservoirs on the supply, the Rathduff and Cherrymount reservoirs. The Rathduff reservoir feeds the Cherrymount reservoir. Both reservoirs were constructed in 1959-1960. The Cherrymount reservoir was visited during the audit. There was vegetation growing around the edges of the inspection hatches and it was noted that there were small holes in the hatches that could allow the ingress of contamination into the reservoir (see Photo 3). b. The caretaker outlined that residual chlorine levels are monitored several times a week on the network and are logged.
<p>4.</p>	<p>Exceedances of the Parametric Values</p> <ul style="list-style-type: none"> a. There was a <i>Cryptosporidium</i> detection for a sample taken on 07/02/2017. There has been no <i>Cryptosporidium</i> detection since then.

Photo 3 Inspection hatch on Cherrymount Reservoir

8. Irish Water should prioritise the Rathduff and Cherrymount Reservoirs on the inspection and maintenance programme to ensure that there is no ingress into the reservoir. This work should be done as soon as possible after the completion of the filtration and UV upgrade works.

9. Irish Water should ensure that all hatches on the reservoirs are secured against ingress of animals or deliberate introduction of any contaminant or acts of vandalism.
