Drinking Water Audit Report

County:	Laois	Date of Audit:	23 rd June 2016
Plant(s) visited:	Convent Borehole Durrow No. 1 PWS (1600PUB1002)	Date of issue of Audit Report:	1 st July 2016
		File Reference:	DW2016/119
		Auditors:	Aoife Loughnane Pauline Gillard
Audit Criteria:	<ul style="list-style-type: none"> • The <i>European Union (Drinking Water) Regulations 2014 (S.I. 122 of 2014)</i>. • The <i>EPA Handbook on the Implementation of the Regulations for Water Services Authorities for Public Water Supplies (ISBN: 978-1-84095-349-7)</i> • The recommendations specified in the <i>EPA Drinking Water Report</i>. • EPA Drinking Water Advice Notes No.s 1 to 15.

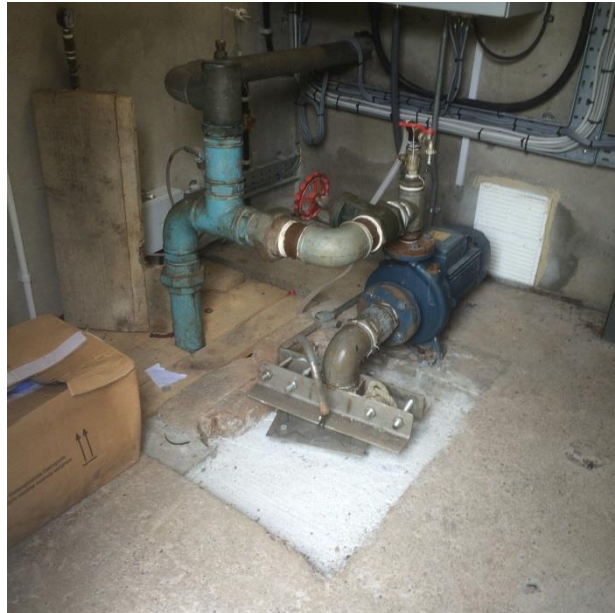
<p>1.</p>	<p>Source Protection</p> <ul style="list-style-type: none">a. The Convent borehole is located directly south of the Erkina River and is accessed through the grounds of Castle Durrow. No borehole logs are available. The borehole is not capped but is located in a locked building.b. According to the EPA Groundwater Monitoring Programme Site Information Report (August 2011), the borehole is 10 m deep and is situated in Dinantian Lower Impure Limestones. The aquifer is a regionally important karstified bedrock dominated by diffuse flow (Rkd). The zone of contribution (ZOC) delineated for this raw water source is 1.61 km² located mainly to the south of the borehole. Groundwater vulnerability within the ZOC ranges from high to extreme.c. Land use within the ZOC is mainly agricultural with some forestry.d. Laois County Council confirmed there are high background levels of nitrate in the groundwater source (generally in the region of 30 to 40 mg/l) but there have been no nitrate exceedances in the drinking water supply in recent years.e. On 31st December 2015, Laois County Council shut-down the water supply due to concerns about rising flood levels at the Convent borehole during a winter storm. While the ground surrounding the plant was not flooded, some floodwater entered the borehole through shallow subsurface flow. Irish Water notified the EPA that Durrow No. 1 PWS was shut-down from 31st December 2015 to 4th January 2016 due to flooding in the area. The supply was fed by Fermoy WTP during the shut-down. Prior to bringing the Convent WTP back into supply, the borehole was purged and pumped to waste until the chlorine levels recovered, and microbiological samples of treated water were clear. In subsequent emergency works, Laois County Council raised the well-head by 18 inches to reduce the risk of ingress re-occurring.f. The Convent borehole is included in Irish Water's Raw Water Monitoring Programme to determine the appropriate level of treatment to ensure the safety and security of the water supply. A UVT monitor and <i>Cryptosporidium</i> sampler has been installed at the plant and sampling commenced in Q1 2016. There has been no detection of <i>Cryptosporidium</i> oocysts to date.g. There are 3 redundant boreholes located within the fenced off area of the site. IE Consulting have been engaged to decommission these boreholes, and the expected timeframe is end of Q3 2016.

Photo 1: Convent borehole – raised well-head

1. Irish Water should ensure that all redundant boreholes are decommissioned in accordance with best practice guidelines, to prevent the risk of presenting a preferential pathway for the entry of contaminants to the aquifer.
2. Irish Water should ensure that all borehole linings, seals and well-heads are installed and maintained in accordance with *EPA Advice Note No. 14: Borehole Construction and Wellhead Protection*.

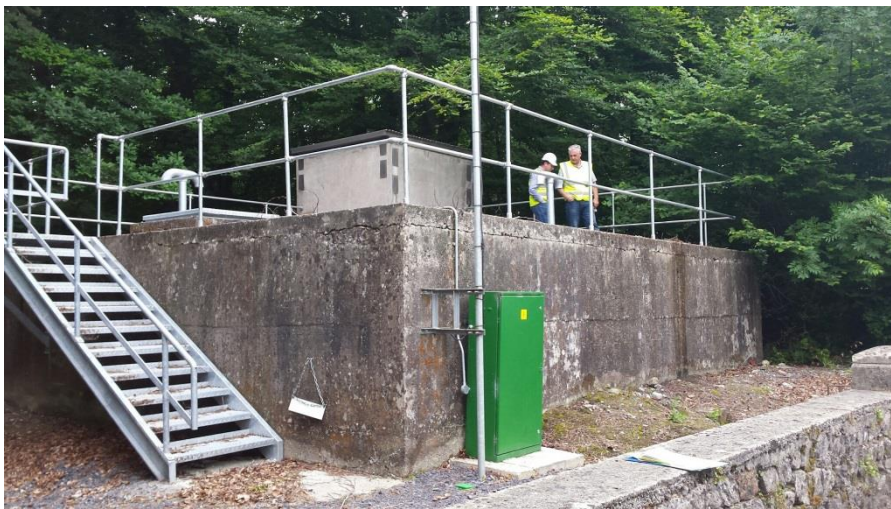
4.	<p>Treated Water Storage</p> <p>a. Treated water is pumped to the Cork Road reservoir located approximately 2kmsouth west of Durrow. The reservoir is thought to have been built in the 1930s and has a storage capacity of 120 m³ in a single cell. The reservoir was visited during the audit.</p> <p>b. The reservoir was partially upgraded in 2015, mainly for health & safety reasons. The upgrade works involved new steps and handrails, covered vents, locked access hatches and new roof and vents on the plate aerator housing structure (see photos 2 & 3). However, the reservoir has not been internally inspected or cleaned in recent times, and an integrity assessment has not been carried out.</p> <p>c. Laois County Council has identified this reservoir for inclusion in Irish Water’s reservoir remediation programme due to leakage concerns.</p>

Photo 2: Cork Road Reservoir

3. Irish Water should carry out an integrity assessment of the Cork Road reservoir to ensure that there is no ingress into the reservoir.

4. Irish Water should ensure that the Cork Road reservoir is inspected and cleaned out on a regular basis and any maintenance and repairs completed as soon as possible after the need has been identified.

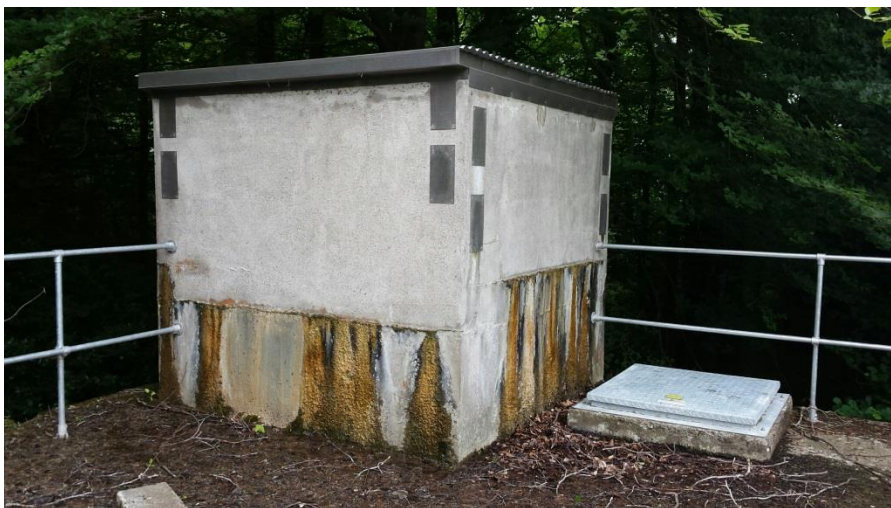
Photo 3: Recent upgrade works to the reservoir's plate aerator housing structure
