Drinking Water Audit Report

County:	Roscommon	Date of Audit:	23 rd June 2015
Plant(s) visited:	Lisbrock Drinking Water Treatment Plant (serving Lisbrock PWS).	Date of issue of Audit Report:	26 th May 2015
		File Reference:	DW2013/12
		Auditors:	Ms Yvonne Doris (lead auditor) Ms Michelle Roche Ms Aoife Loughnane.
Audit Criteria:	<ul style="list-style-type: none"> • The <i>European Union (Drinking Water) Regulations 2014 (S.I. 122 of 2014)</i>. • The <i>EPA Handbook on the Implementation of the Regulations for Water Services Authorities for Public Water Supplies (ISBN: 978-1-84095-349-7)</i> • The recommendations specified in the <i>EPA Drinking Water Report</i>. • The recommendations in any previous audit reports.

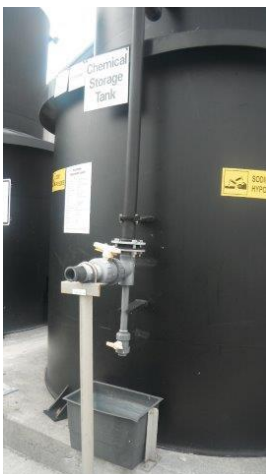
Photograph 1: Example of delivery pipe to bulk storage tank not within bunded area.

7. Irish Water should review chemical storage arrangements at the treatment plant. Fill points for storage tanks should be within a bunded area. Refer to EPA guidance document –“*IPC Guidance Note on Storage and Transfer of Materials for Scheduled Activities*”.
