# Drinking Water Audit Report

<b>County:</b>	Co. Sligo	<b>Date of Audit:</b>	15/06/2016
<b>Plant(s) visited:</b>	Lough Easkey Water Treatment Plant (WTP) and abstraction point  Scheme Code: 2700PUB2704	<b>Date of issue of Audit Report:</b>	29/06/2016
		<b>File Reference:</b>	DW2016/108
		<b>Auditor:</b>	Ms Ruth Barrington
<b>Audit Criteria:</b>	<ul style="list-style-type: none"> <li>• The <i>European Union (Drinking Water) Regulations 2014 (S.I. 122 of 2014)</i>.</li> <li>• The <i>EPA Handbook on the Implementation of the Regulations for Water Services Authorities for Public Water Supplies (ISBN: 978-1-84095-349-7)</i></li> <li>• The recommendations specified in the <i>EPA Drinking Water Report</i>.</li> <li>• EPA Drinking Water Advice Notes Nos. 1 to 15.</li> <li>• The recommendations in a previous EPA audit report dated 2<sup>nd</sup> April 2009.</li> </ul>

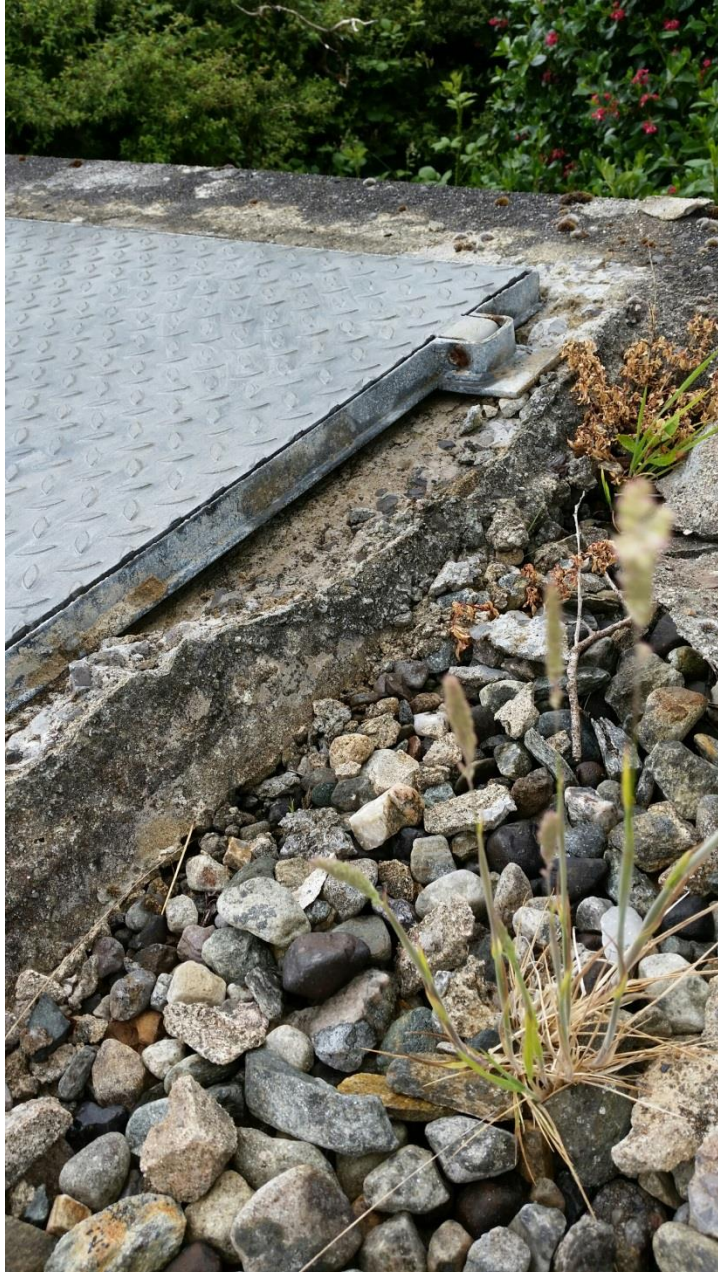
5.	<p><b>Hygiene and Housekeeping</b></p> <ol style="list-style-type: none"> <li>a. The concrete edge of one of the hatches on the clearwater tank was broken (refer to photograph No. 1 attached). It appeared that surface water ingress may be possible at this point. The hatches at the clearwater tank were not lockable.</li> </ol>

Photograph No. 1: Cracked concrete around hatch on clearwater tank

7. Irish Water should ensure that sealed and lockable covers are installed at the two clearwater tank hatches where there is access to treated water.
