# Drinking Water Audit Report

<b>County:</b>	Wicklow	<b>Date of Audit:</b>	9 <sup>th</sup> May 2018
<b>Plant visited:</b>	Ballingate (scheme code 3400PUB1057)	<b>Date of issue of Audit Report:</b>	22 <sup>nd</sup> May 2018
		<b>File Reference:</b>	DW2018/90
		<b>Auditors:</b>	Aoife Loughnane Michelle Minihan
<b>Audit Criteria:</b>	<ul style="list-style-type: none"> <li>• The <i>European Union (Drinking Water) Regulations 2014 (S.I. 122 of 2014)</i>, as amended.</li> <li>• The <i>EPA Handbook on the Implementation of the Regulations for Water Services Authorities for Public Water Supplies (ISBN: 978-1-84095-349-7)</i></li> <li>• The recommendations specified in the <i>EPA Drinking Water Report</i>.</li> <li>• EPA Drinking Water Advice Notes No.s 1 to 15.</li> </ul>

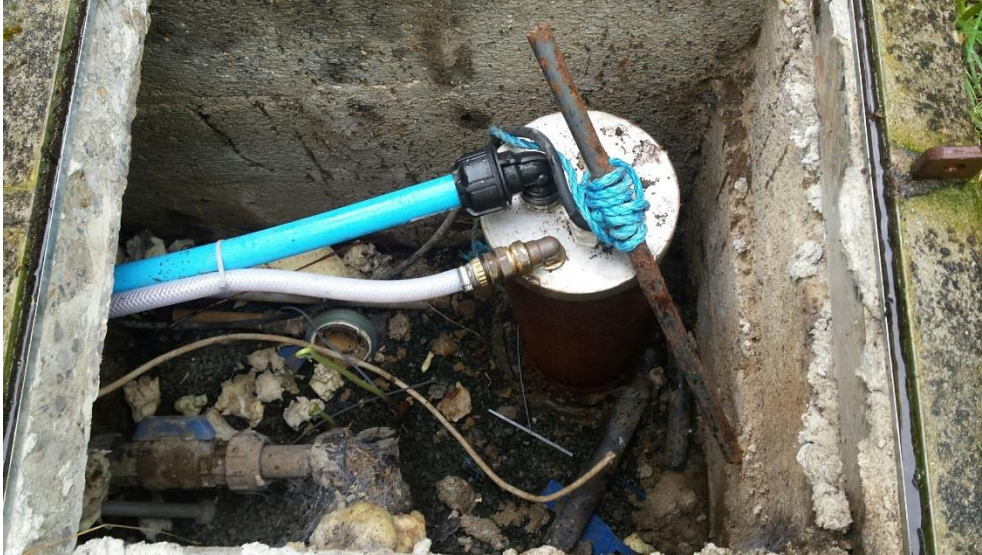
<b>1.</b>	<p><b>Exceedances of the Parametric Values</b></p> <ul style="list-style-type: none"> <li>a. On 30/04/18 Irish Water notified the EPA of a coliform bacteria exceedance of 78/100ml in a check sample at Ballingate public water supply on 25/04/18. <i>Enterococci</i> was detected in a follow up sample taken on 03/05/18.</li> <li>b. Following consultation with the HSE, Irish Water issued a Boil Water Notice to all 15 consumers on the Ballingate PWS on 30/04/18.</li> <li>a. Irish Water has reported no issues with the operation of the UV disinfection system at Ballingate treatment plant. There is no chlorination of the supply to maintain a residual disinfectant in the distribution network because the area served is so small (5 houses).</li> <li>c. Sampling undertaken on 9<sup>th</sup> &amp; 10<sup>th</sup> May has found no further microbiological exceedances.</li> </ul>
<b>2.</b>	<p><b>Source Protection</b></p> <ul style="list-style-type: none"> <li>a. The borehole is located in an underground chamber at the treatment plant. The borehole construction details are unknown.</li> <li>b. The auditors observed the return water from the turbidity monitor being piped back into the borehole (see photo 1). This is not considered best practice in terms of risk of contamination of the groundwater source.</li> </ul>

**Photo 1: Ballingate Borehole (note the return water from the turbidity monitor being discharged back into the borehole via the white pipe).**

1. Irish Water should ensure that the UV disinfection system operates within its validated range at all times. A copy of the UV validation certificate should be kept at the treatment plant.
2. Irish Water should ensure that the performance of the UV disinfection system can be reviewed and verified, by providing access to the trended operational data (flow and UV intensity) either at Ballingate water treatment plant or remotely on a SCADA system.
3. Irish Water should cease the practice of disposing the return water from the turbidity monitor back into the borehole, to minimise the risk of contamination of the groundwater source.
