Coastal Lagoons: Ecology and Restoration (CLEAR)

Authors: Brendan O'Connor, Geoff Oliver, Tony Cawley, Cilian Roden, Philip Perrin, Rutger de Witt, Kevin McCaffrey and Aisha O'Connor

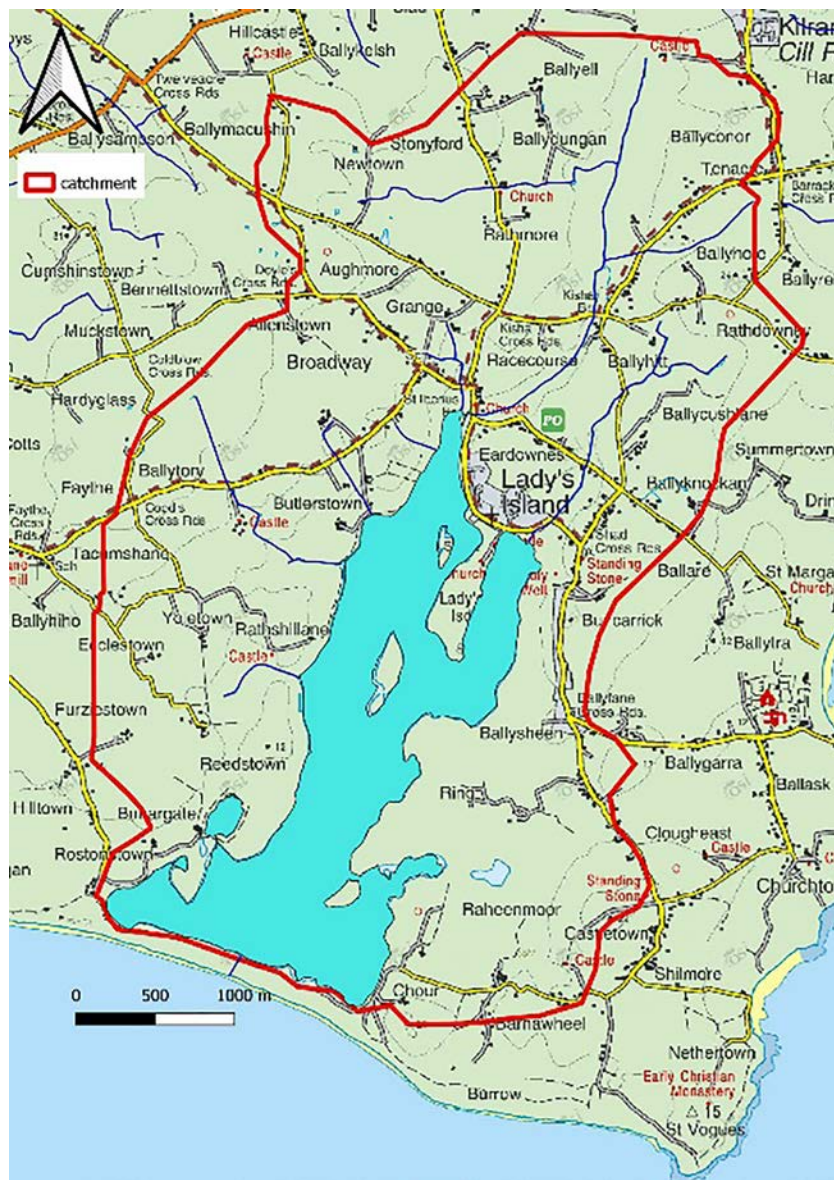
Figure 2.1. Lady’s Island Lake and catchment extent.

The lake discharges to the sea via a man-made cut in the sand dune barriers located at the southeast corner of the lake. This cut is based on the first edition Ordnance Survey Ireland 6-inch mapping and was opened in 1840 to relieve flooding in the lake. This cutting is opened each year to control flood levels

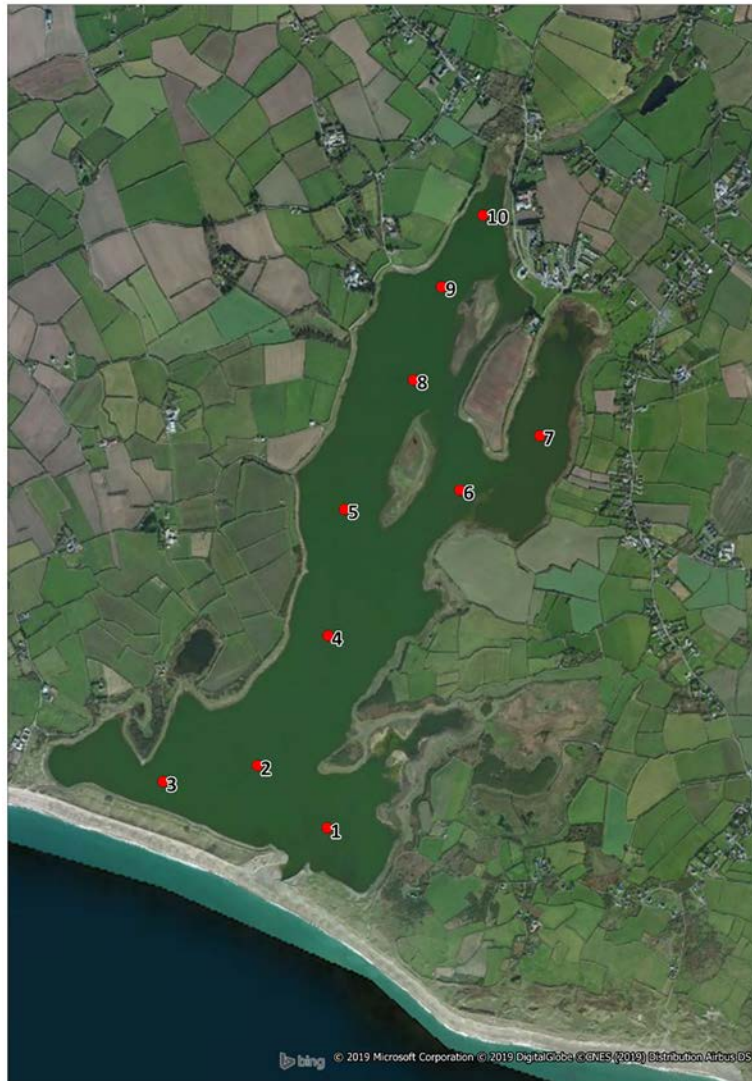
Figure 4.1. Location of the sites (B1–10) at which the SPI diver-operated camera was deployed in Lady's Island Lake.

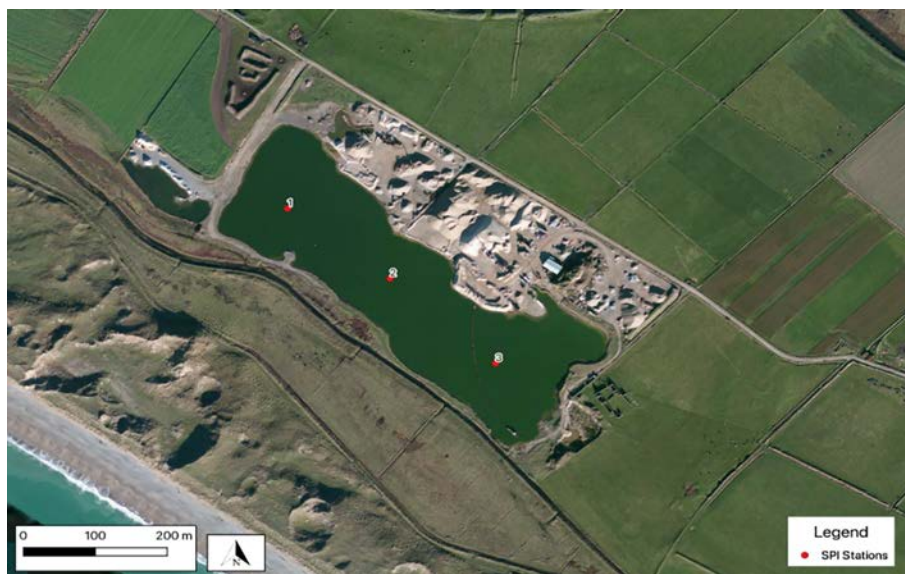
Figure 4.2. Ballyteige Lagoon showing the locations of the stations (Ballyteige 1–3) where SPI images were collected.

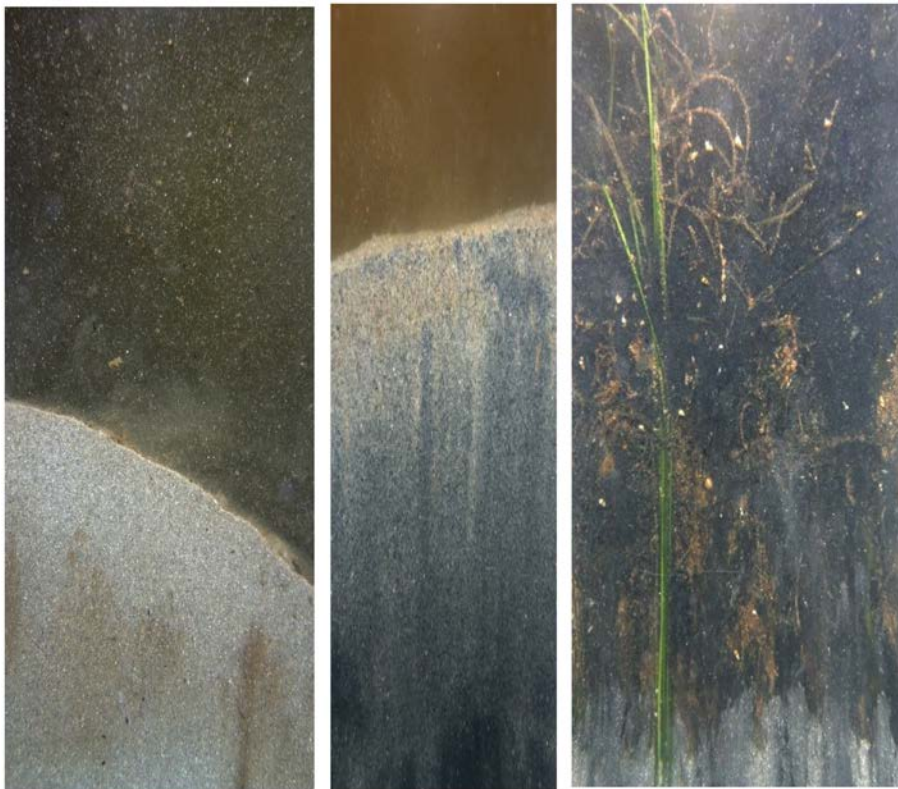
Figure 4.4. SPI from Ballyteige Lagoon.

Ballyteige 2a, 2b and 2c. At station 2 redox conditions are poorer than at station 1, with hypoxic conditions close to or at the surface. Some *Ruppia* sp. was imaged at this location. Successional stage (OSI) is scored at 1.

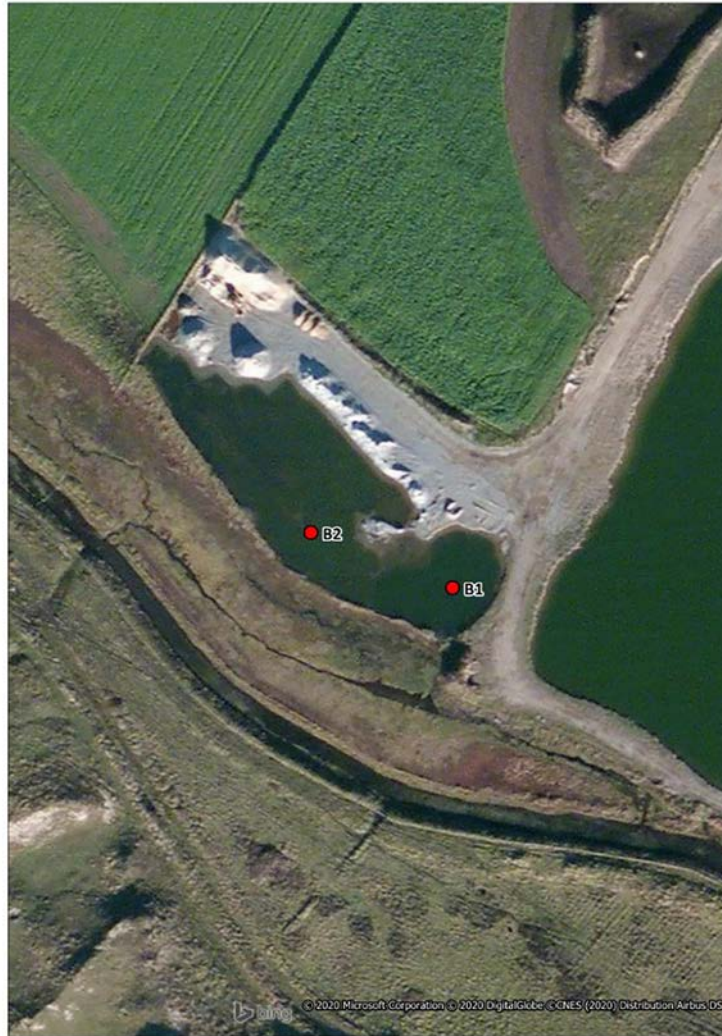
Figure 4.5. Locations of two grab stations in Ballyteige Lagoon.

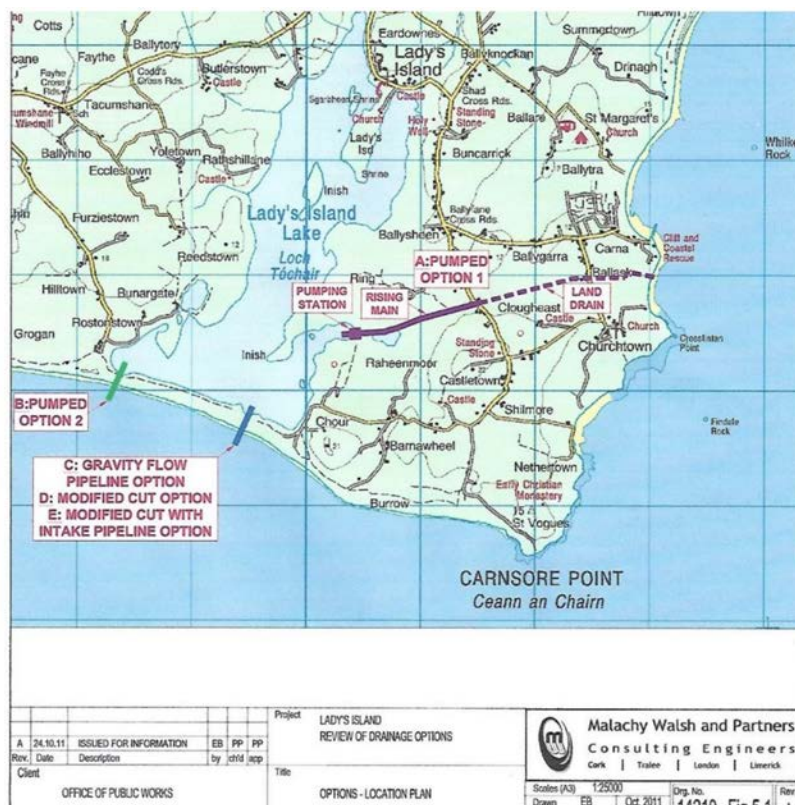
Figure 5.1. Map of Lady's Island Lake showing possible solutions for controlling water levels. Reproduced with kind permission of Malachy Walsh.

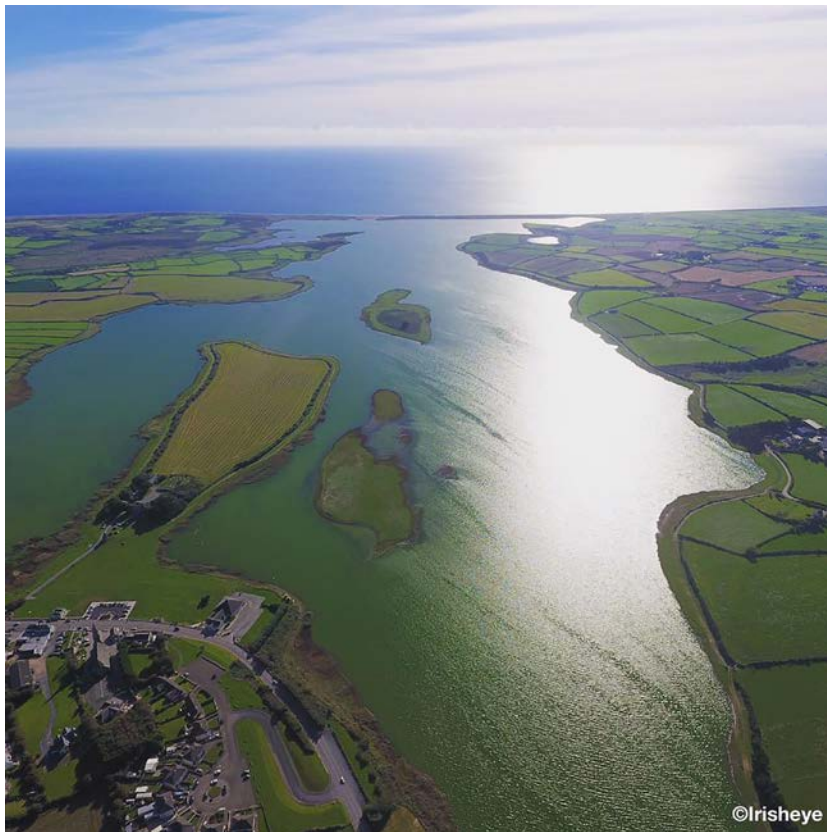
Figure 5.2. Aerial photograph of Lady’s Island Lake showing the intensive agriculture along the shoreline of the lake and the great potential for ICWs and for amenity and conservation areas. Photo credit: Riccardo Conway.
